# Existing Conditions – Traffic

**Glenn Highway  
& Hiland Road**  
Interchange Improvements

# Current Approach to Non-Motorized Facilities

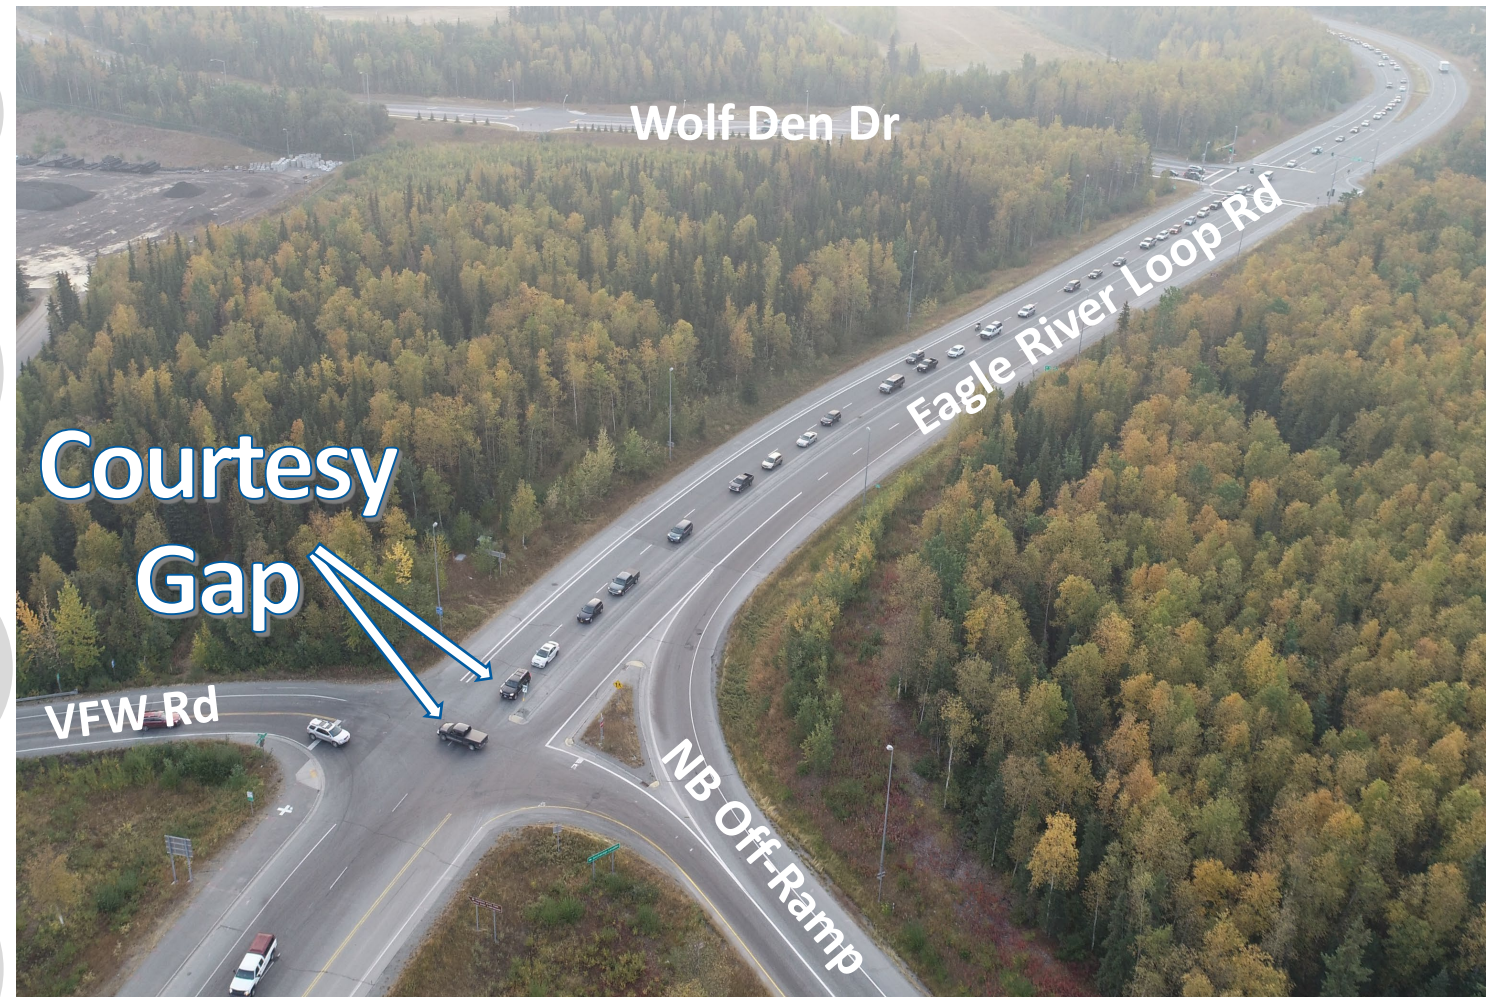
Drivers in rolling queue let side street drivers in (courtesy gap)

Drivers prepare for single lane turn in advance, using single lane through the Wolf Den Drive signal

Rolling queue entering the southbound on-ramp causes insufficient gaps in the a.m. peak

Long westbound left-turn morning queues can be seen as far back as Briggs Bridge (1.9 miles)

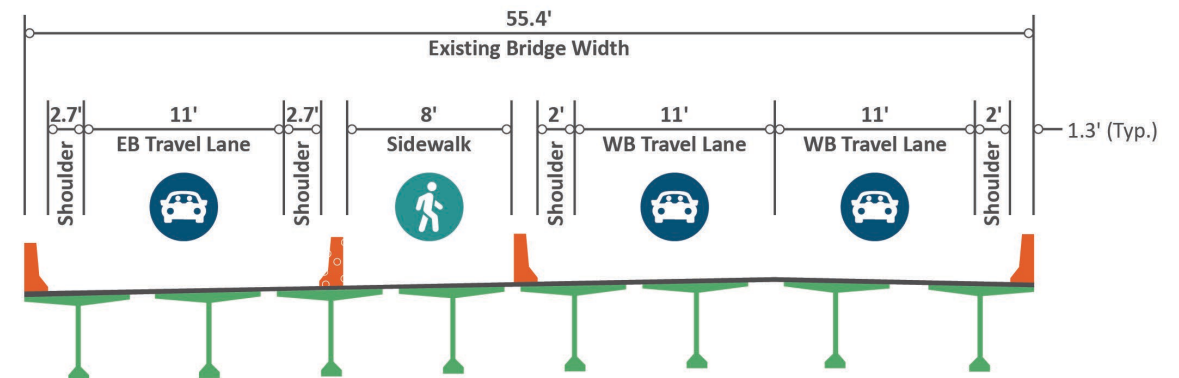
✓ Route pedestrians down the middle of the bridge with barriers

✓ Reduces lane crossings from 8 to 6

✓ Reduces distance from the Park & Ride to the Glenn Hwy pathway from 1,330 feet to 930 feet
